# Inclusive design at bus stops with cycle tracks

**MARCH 2024**

This report has been produced as part of the Living Streets project "Inclusive Design at Bus Stops and Continuous Footways". This project is funded by the Scottish Road Research Board (Transport Scotland) and Department for Transport.

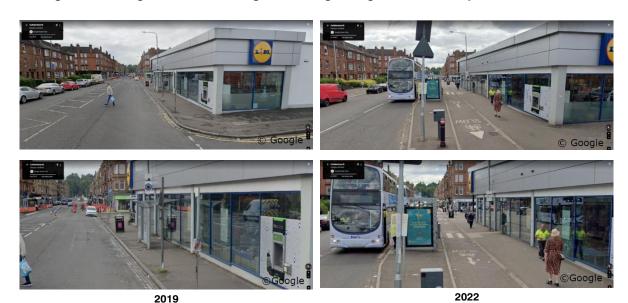
Figure 29: Google Streetview images showing changes to a bus stop

Older Google Streetview images (as shown in Figure 29) show that the older situation had been problematic, with the bus shelter roof covering the whole pavement, and a significant degree of obstruction of the pavement with bins and other street furniture. In contrast, the new arrangement involved the removal of obstructions on the pavement, the addition of a cycle track on what had previously been carriageway, and a bus stop island that was of comparable width than the original pavement. However, we noted that the addition of an advertising panel on the bus shelter may have restricted movement (and visibility) at the stop itself.

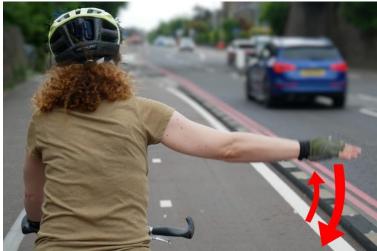
Figure 30: Cyclist hand/arm signals

The British Highway Code mandates that a cyclist holds their whole right arm out horizontally to their side, with the hand palm down, moving their entire arm upwards and downwards. Images of both signals are shown in Figure 30.

Danish signal

British signal

- Considerably faster and less awkward to use
- More clearly different from a "turning right" signal
- More naturally meaningful to indicate "stopping"
- Somewhat less destabilising
- Usable even if another cyclist is immediately to the user's right (which we observed can be the case on some busier cycle tracks).
