Inclusive design at bus stops with cycle tracks: Appendix 1

(DETAILED STUDY SITES)
OCTOBER 2023

Introduction and site list

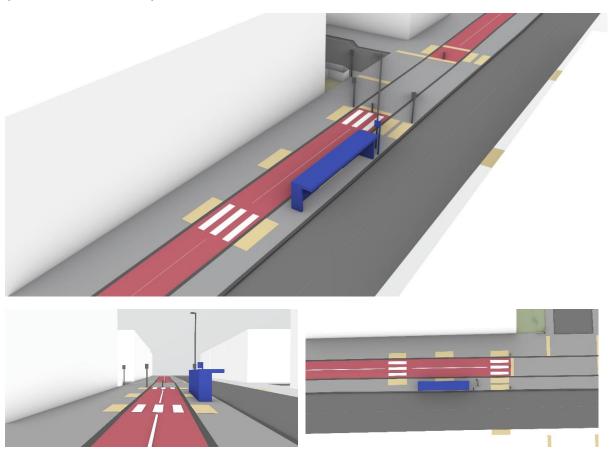
Sauchiehall Street, Glasgow

This bus stop is in the centre of Glasgow, on Sauchiehall Street, which contains many shops, restaurants, and other similar establishments, and which is also a very busy pedestrian route (for wider reasons).

The street carries one-way traffic with two lanes, although parking and/or stopping is allowed on both sides of the carriageway meaning there was usually only a single lane of moving vehicles (which slaloms between stopped vehicles).

The cycle track is two-way and at footway level. There is a slightly raised strip separating the two (intended to be detectable by blind or partially sighted people).

The bus stop is on a long multi-use island. The cycle track is straight.

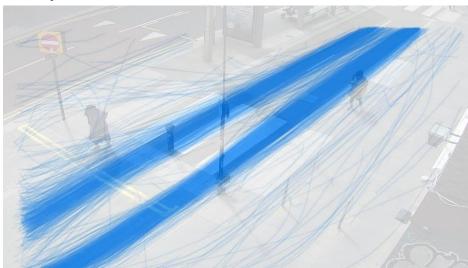
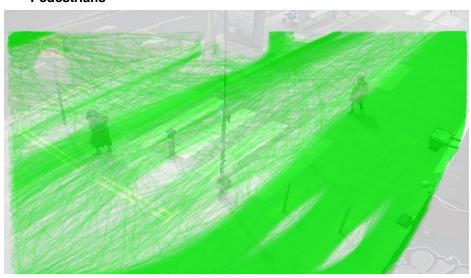
This is a busy-complex environment. Although cycling levels are relatively low, levels of pedestrian use of the street are high. Groups or pairs of pedestrians are quite common. As can be seen in the path trace diagram overleaf, many pedestrians (traced in green) are crossing the street. While most pedestrians stay off the cycle track, it is common to see pedestrians walking for lengthy periods along it, standing on it, or crossing it very slowly.

Many pedestrians can be seen to walk along the back of the bus shelter, on or immediately beside the track.

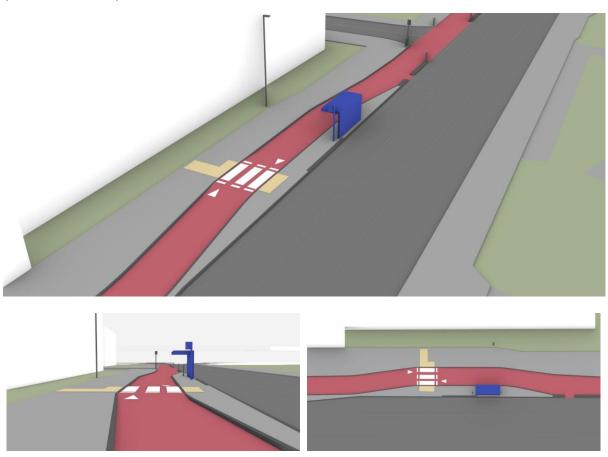
Garscube Road, Glasgow

The cycle track carries two-way cycling. For most of the nearby length of carriageway there are three lanes for vehicles.

There is a zebra crossing on the track, properly marked with blister-style tactile paving. The 'tail' of this extends to the edge of the pavement, providing a means to identify the crossing location (and the bus stop).

The cycle track is set below the pavement, with reduced height 'forgiving' kerbs (angled face rather than vertical face).

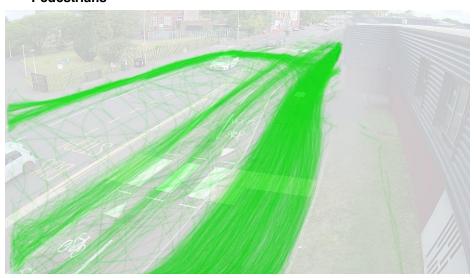
Pedestrians

The signalised crossing (i.e. with traffic lights) around 50m north of the shelter introduces some pedestrian behaviours that would otherwise be absent. It was very common for pedestrians, who had used or intended to use the crossing, to walk along the island at the bus stop or signals, stepping onto the track and walking along the edge of this at the point it becomes narrower. Such behaviours were seen even in pedestrians who would have had an easier time crossing to the normal pavement, for example while pushing a child's buggy.

This behaviour can be seen to show up in the (green) path trace image below.

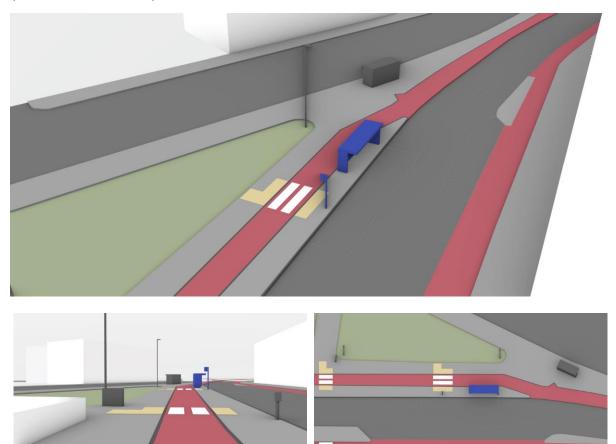
Victoria Road, Glasgow

There is a signalised crossing of the carriageway from the bus stop island to a substantial island of pavement sitting between the carriageway and the cycle track on the opposite side of the carriageway.

The cycle track is below pavement height. There are forgiving kerbs (angled rather than vertical face) to the left of the track (i.e. relative to the direction cycled). To the right the kerbs are of a lower-than-standard height, but these have a vertical face.

The cycle track climbs gently to pavement height at three zebra crossings. Only one of these crossings is more obviously associated with the bus stop itself – with the other two close beside the signalised crossing.

There appears to be a problem caused by the presence of the advertising panel to the north end of the bus shelter (sitting beside the front of the bus with the green roof in the above images). A proportion of pedestrians were observed, on alighting from a bus, to squeeze around this panel, crossing the track on a route northwards. This meant that they crossed the track at the point the track bends back toward the carriageway, where it is hidden from cyclists. We observed a few closer interactions between cyclists and pedestrians here, clearly unanticipated by either.

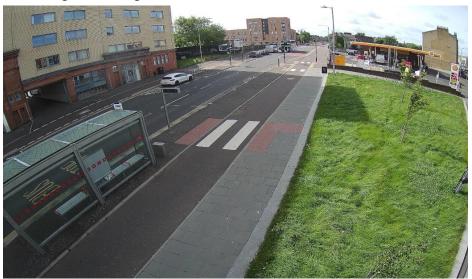
Background image

We observed a pedestrian standing on the track at this bus stop for prolonged periods during at least a 17 minute wait for a bus (our recording began after his arrival, and ended before his departure). It was clear that he understood the status of the track, as he would move from it when cyclists were approaching, but that he felt comfortable to stand in this space.

There was almost no cycling on the carriageway here. There was some wrong-way cycling, and cycling on the pavement, associated with cyclists coming from Eglinton Road – who had no other clear route to join the southbound route. These cyclists would typically cross to the southbound cycle track once they found a location where they could avoid bumping up and down kerbs.

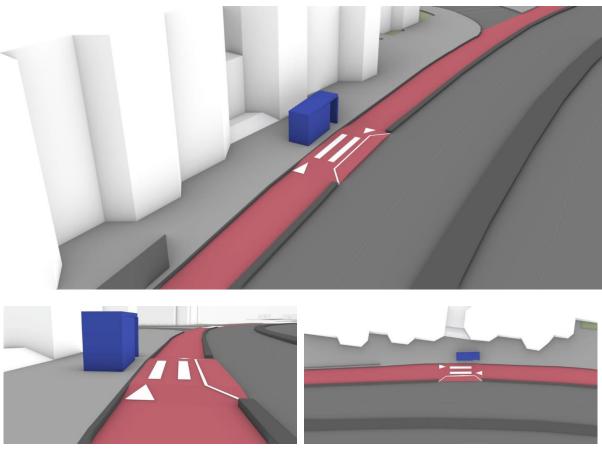
Newport Rd, Cardiff

This is a shared platform boarder design (see Appendix 2 for an account of our naming system).

A two-way cycle track has been created through the use of 'light' segregation, meaning that cyclists are using what was previously the carriageway surface.

In the images above, the track is shown in red, however in reality it is of asphalt. There is, however, an obvious zebra crossing highlighting the presence of the shared platform boarder.

There is a white line marking the edge of the cycle track, providing a small area for pedestrians to step onto on alighting from a bus.

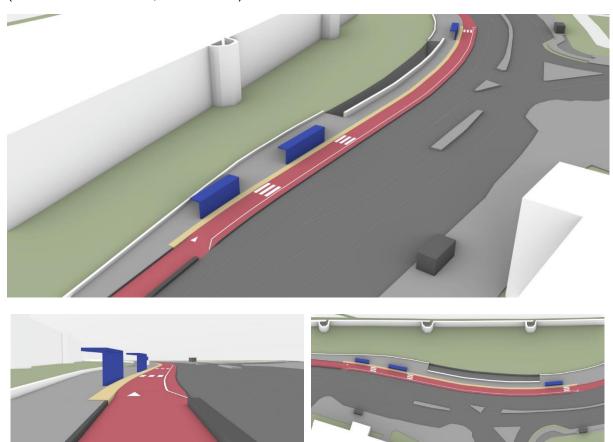
Kingsway, Cardiff

We have described the design here as a hybrid between a shared platform boarder design, and a continued kerbside track design (see Appendix 2 for definitions). The cycle track is two-way (bi-directional).

In the images above, the whole track is coloured red. In reality, as seen in the photographs below, the main track is of grey asphalt, lightly segregated from the carriageway (i.e. with cyclists on what was previously carriageway surface), whereas the track on the platform area is red.

There is corduroy-style tactile paving marking the edge of the cycle track along its raised length (which is at pavement level) – which is of around 100m. The carriageway here is of around 20m width.

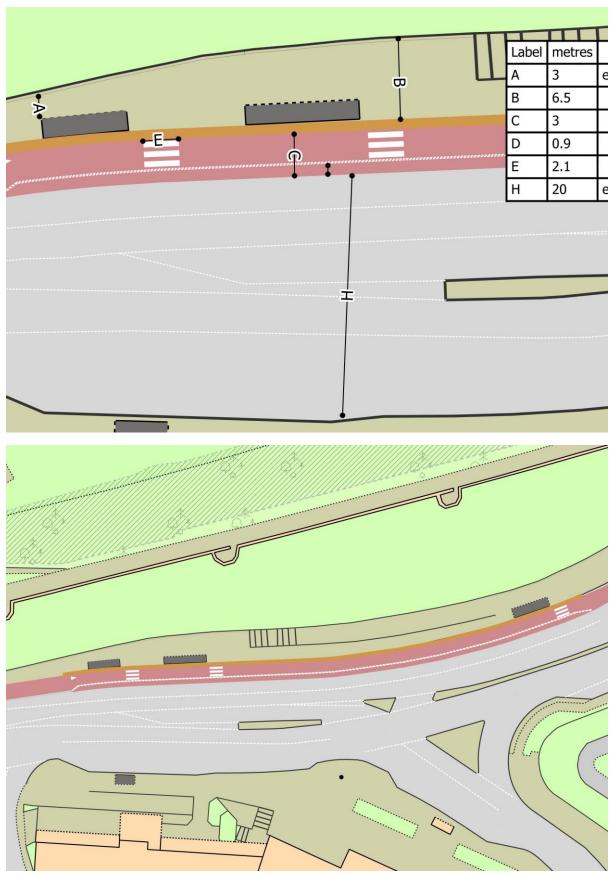
Plans

'e' indicates estimated dimension Background mapping © Crown copyright 2023, OS 100046668

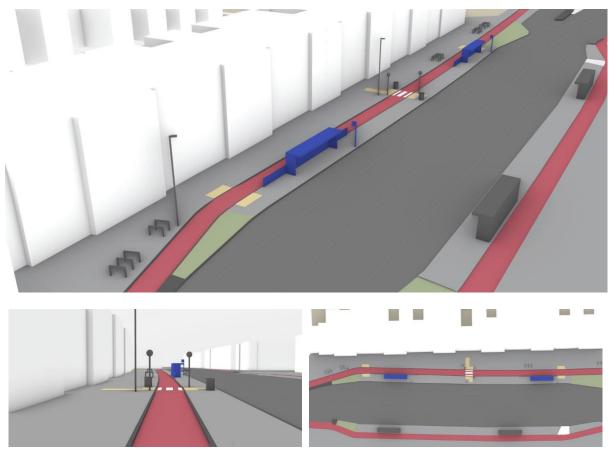
Oxford Road, Manchester

There are two bus stops on a long island.

There are three places where the cycle track is raised to pavement level to provide kerb-free crossing points. One of these crossing points is marked with a zebra crossing, which (unusually) includes 'Belisha' beacons. This is marked in a standard way with tactile paving – although the 'tail' of this does not reach the building line. The other two crossing points lack any zebra markings – and have standard tactile paving marking the absence of the kerb.

There are three rumble strips on the cycle track 4.5-6m ahead of the uncontrolled crossing points, and "look left"/"look right" is painted on the track for pedestrians to read.

There are three rumble strips on the track 4-5.5m before the zebra crossing, and a bollard with a small give way sign on it around 2m before it. The rear of this, and a second bollard have 'look for cyclists' written on them.

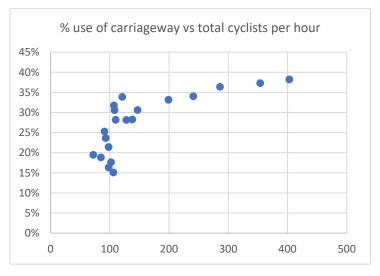
The graph below charts the percentage of cyclists on the carriageway against the number of cyclists passing (northbound) in an hour. This shows that as the number of cyclists rose, the percentage staying on the carriageway rose, stabilising at around 30-40%. When cycling levels were much lower, the percentage using the carriageway was only around 15-20%

Because the carriageway has restricted access, traffic conditions on this were calmer than its width might suggest would be the case. There is a substantial gap in the cycle track before the bus stop area (associated with a side road entrance/exit), and an easy route back onto the track after the bus stop. A much higher proportion of cyclists chose to stay on the carriageway here in comparison to at other sites, with this varying from 15% to 38% across different observed hours.

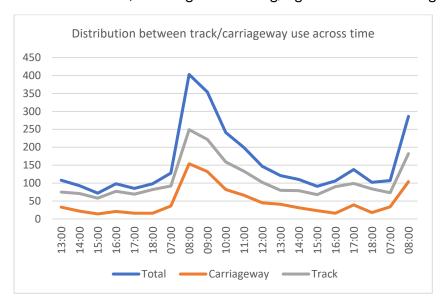
The graph below charts the distribution between cyclists on the track and cyclists on the carriageway across observed study hours (NB: observation stopped after 19:00 and restarted at 07:00, meaning that evening/night hours are missing in this graph).

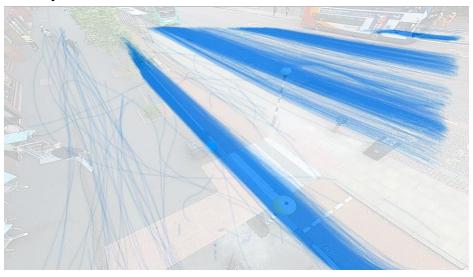
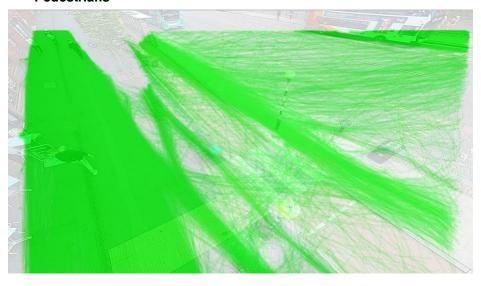
The path trace diagrams below show the relatively high proportion of cyclists using the carriageway (blue traces).

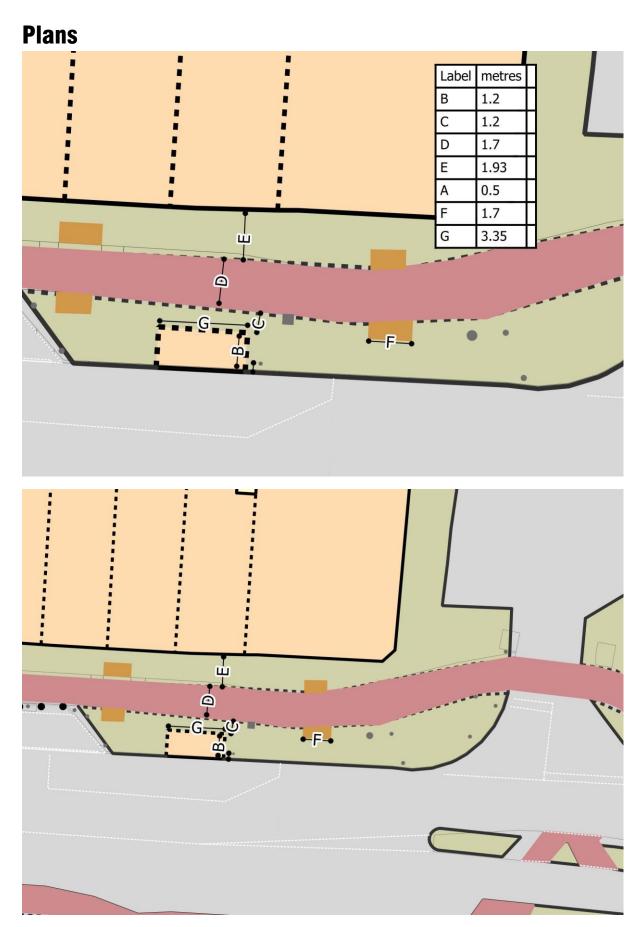
This is a busy-complex environment which provides challenging conditions for cycling, and multiple obstructions for pedestrians. The Living Streets researcher described conditions as "hectic".

There are high numbers of pedestrians, and an inadequate width of pavement for this level of use (generally less than 2m width). There are high numbers of pedestrians crossing the carriageway, or engaged in other activity such as loading or unloading from vehicles. Pedestrians are walking immediately beside the track, and often being forced to encroach on it, with some walking along it. There can be a queue for a cash machine blocking the pavement just before the bus stop (e.g. one person waiting on the outside edge of the pavement, while one uses it at the building line, with just enough space for someone walking to pass between).

There are numerous wiggles in the track. Kerb height is a hazard to cyclists in places. There are regular interruptions of the track at side roads, meaning that cyclists are likely focused on their own safety at these points.

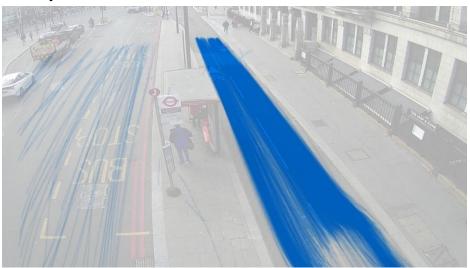
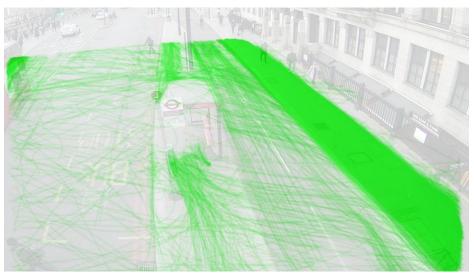
The path trace images below show that pedestrians (green traces) do not generally walk on the cycle track, and that there is very little cycling (blue traces) on the carriageway (and none was detected on the pavement).

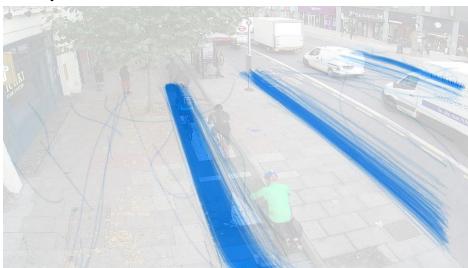
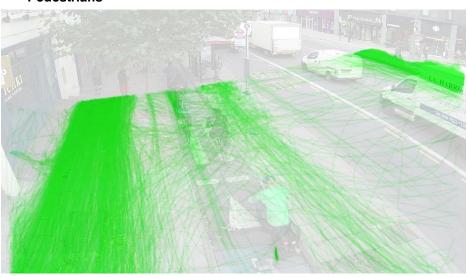
As can be seen on the path trace images below, an unusually high proportion of cyclists (blue traces) remained on the carriageway at the bus stop – many transitioning easily on and off the painted cycle lanes to either side of it. We observed many other uses of the track and carriageway. For example with e-scooters or other battery powered devices.

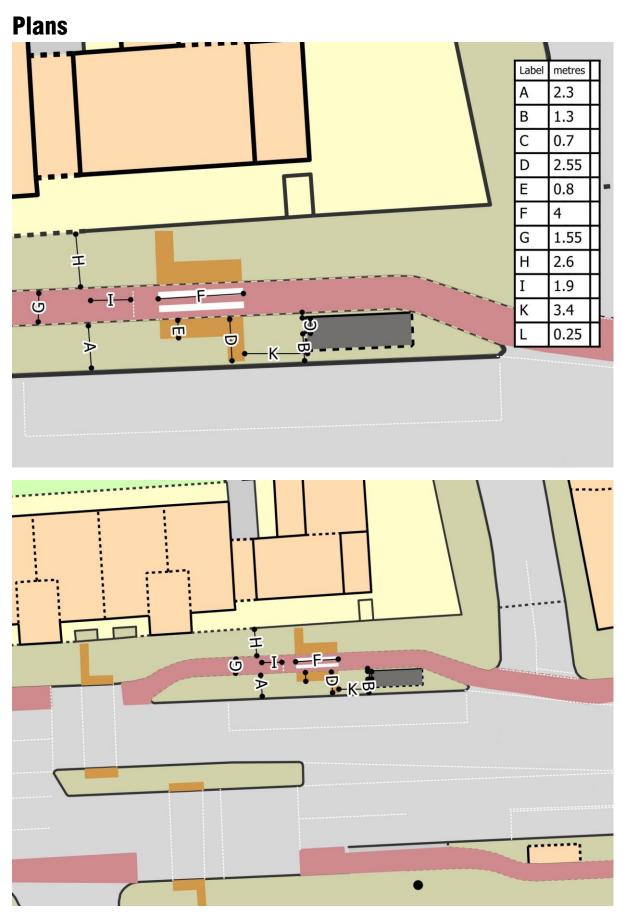
As can be seen in the path trace images (below), a relatively high proportion of cyclists (blue traces) stay on the carriageway here, which seems unsurprising given the layout (as described above).

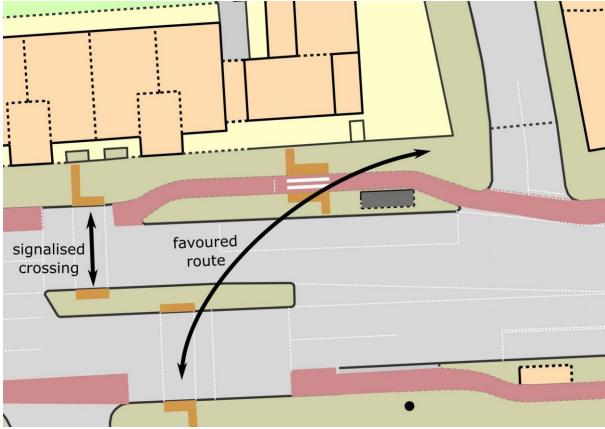
The behaviours adopted by pedestrians crossing the carriageway are of interest, because it was clear that the favoured route (for pedestrians arriving/leaving from/to the east) to cross to a central pedestrian island was by using the bus stop island, rather than by using a signalised crossing. This is described in detail in the main report. In the path trace images below, this can also be seen (traces in green).
