Inclusive design at continuous footways: Appendix 1

(DETAILED-STUDY SITES)

OCTOBER 2023

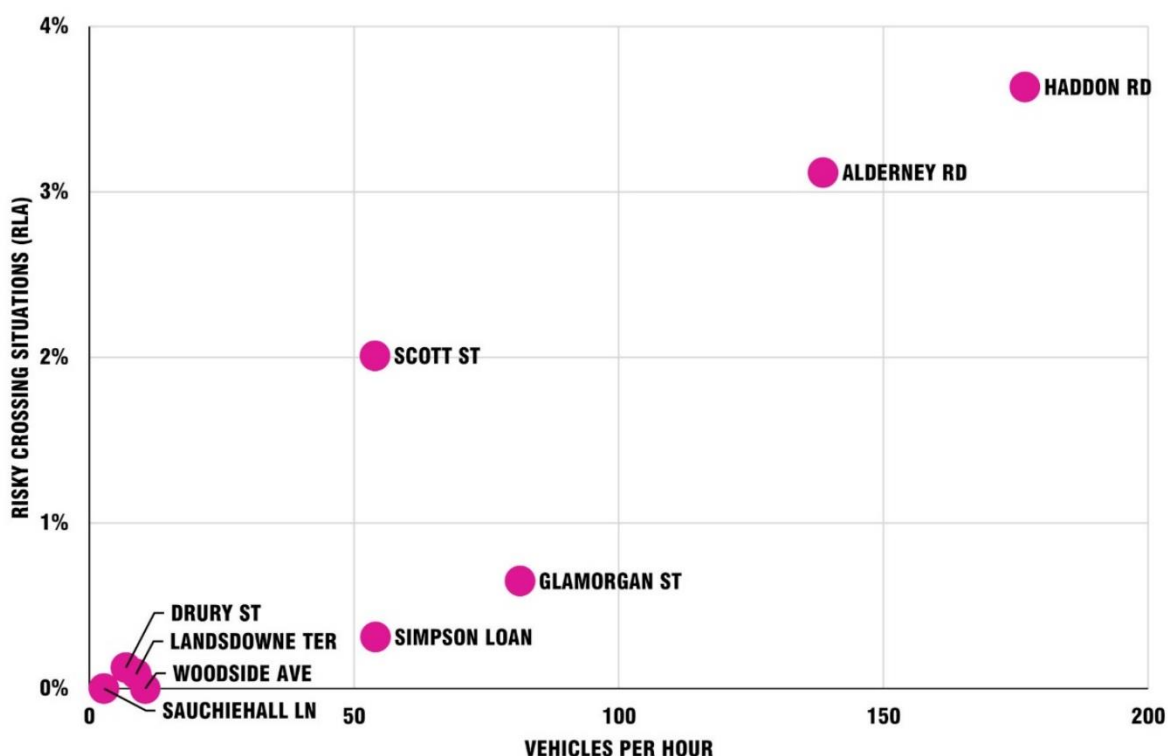
Figure 1: RLA plotted against vehicle volume

Figure 1 below shows the percentage of pedestrian experiences flagged according to the RLA measure, plotted against the number of vehicles crossing the drivable space.

Broadly it can be seen the number of experiences flagged according to the RLA measure are simply a product of the number of vehicles crossing the drivable space.

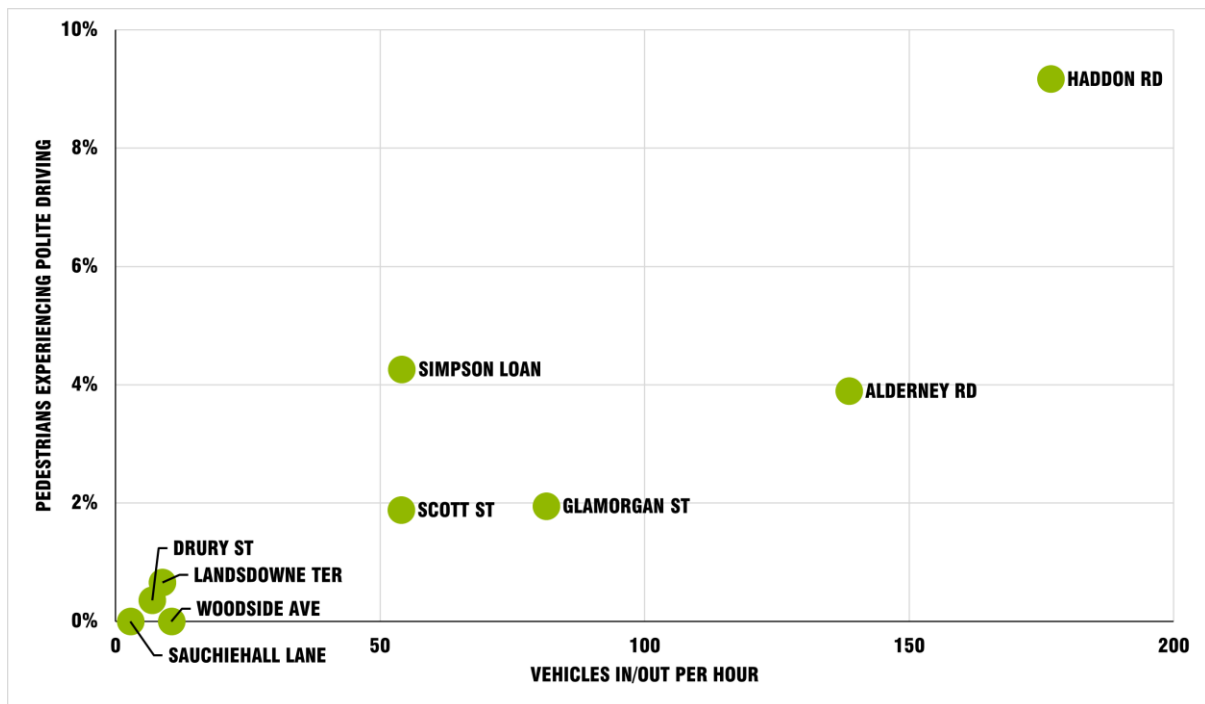
Figure 3: OPD measure plotted against traffic volume

Figure 3 below shows the percentage of pedestrian experiences flagged according to the OPD measure, plotted against the number of vehicles crossing the drivable space.

As with the measures above, broadly it can be seen these are simply a product of the number of vehicles crossing the drivable space.

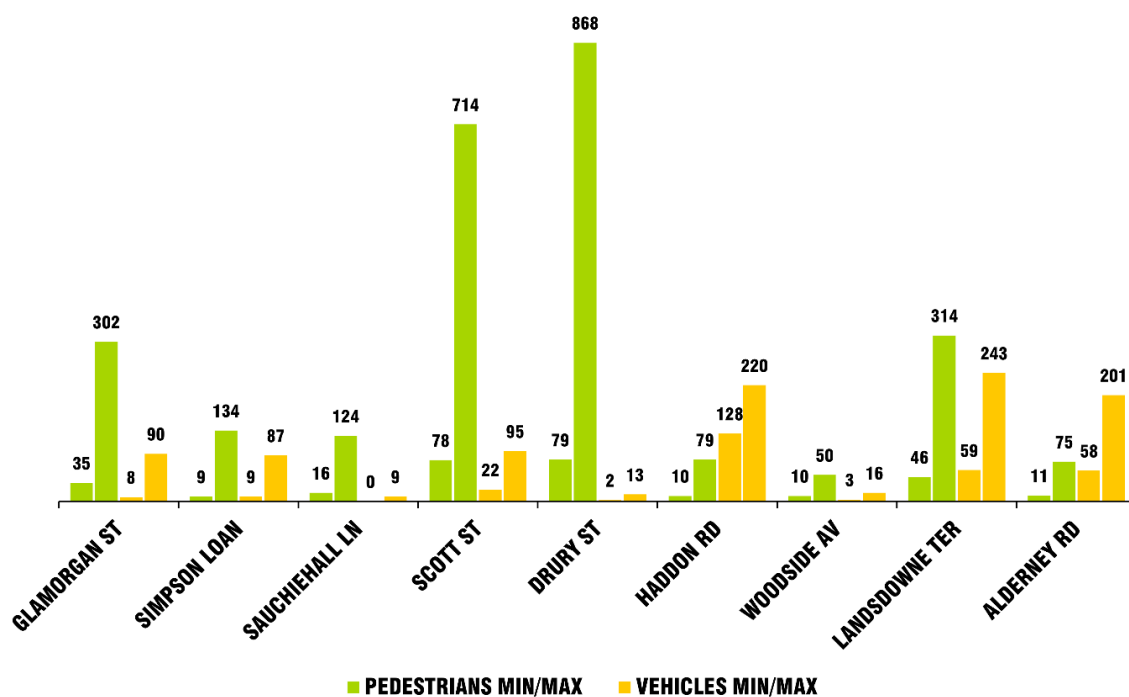
Figure 7: Maximum and minimum pedestrian/vehicle numbers

Figure 7 below compares the number of pedestrians and vehicles crossing the drivable space, broken down to show the maximum and minimum numbers observed in any hourly period (in our study period of 07:00-19:00 hours).

Note that for Lansdowne terrace, a very high proportion of the “vehicles” crossing the drivable space were bicycles and in some of our comparisons we have accounted for this separately.

The balance between pedestrian and vehicle numbers is relevant in comparing sites, but note that the highest and lowest pedestrian numbers did not necessarily occur in the same hours as the highest and lowest vehicle numbers.

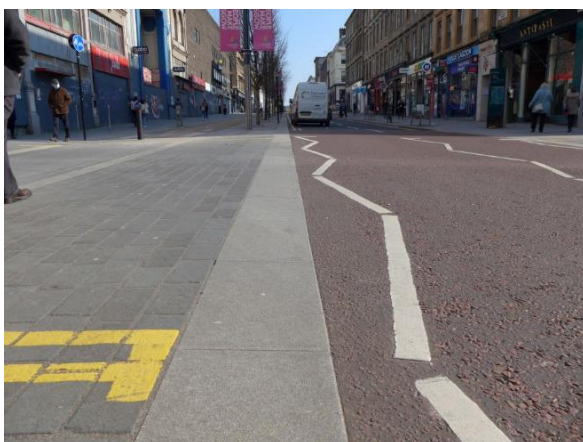
Lack of ramp at edge of main carriageway

There is no ramp between the carriageway surfaces and the drivable space. Unusually there is a ramp in Sauchiehall Street, bringing the *main* carriageway to footway height.

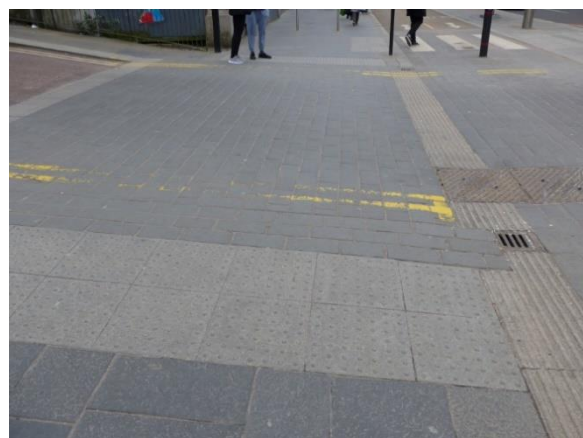
Tactile paving detail (looking toward side road)

There are numerous areas/strips of tactile paving, with blister-style paving marking the edges of what would previously have been the carriageway of Scott Street, blister-style paving marking designated crossing points of the cycle track and of Sauchiehall Street, and corduroy paving alongside the edge of the area intended for cycling at the junction.

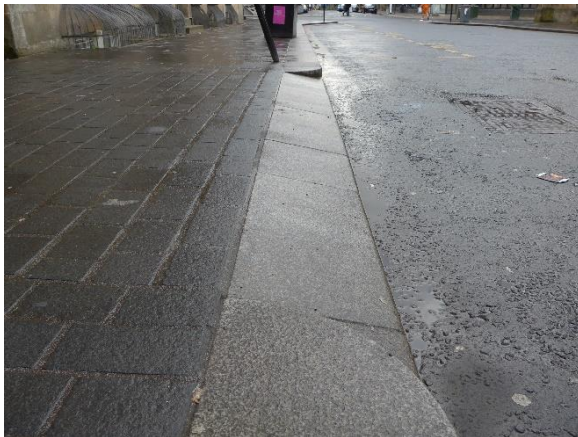
Ramp

There is an unusually sharp (steep/high) ramp between the drivable space and the main carriageway. There is no ramp between this and the lane surface, but the lane surface is rough and poorly maintained, and the narrow space slows vehicles considerably.

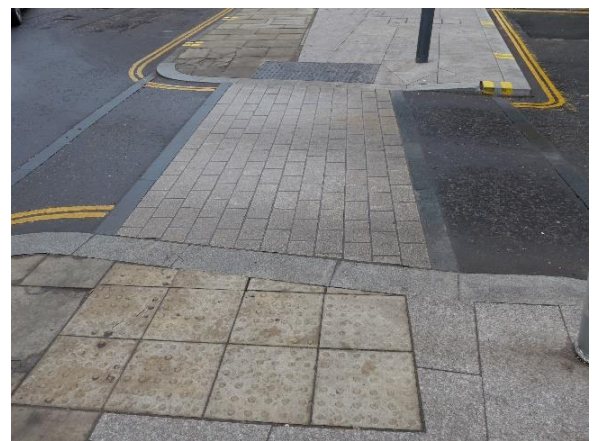
Detail of surfacing and tactile paving

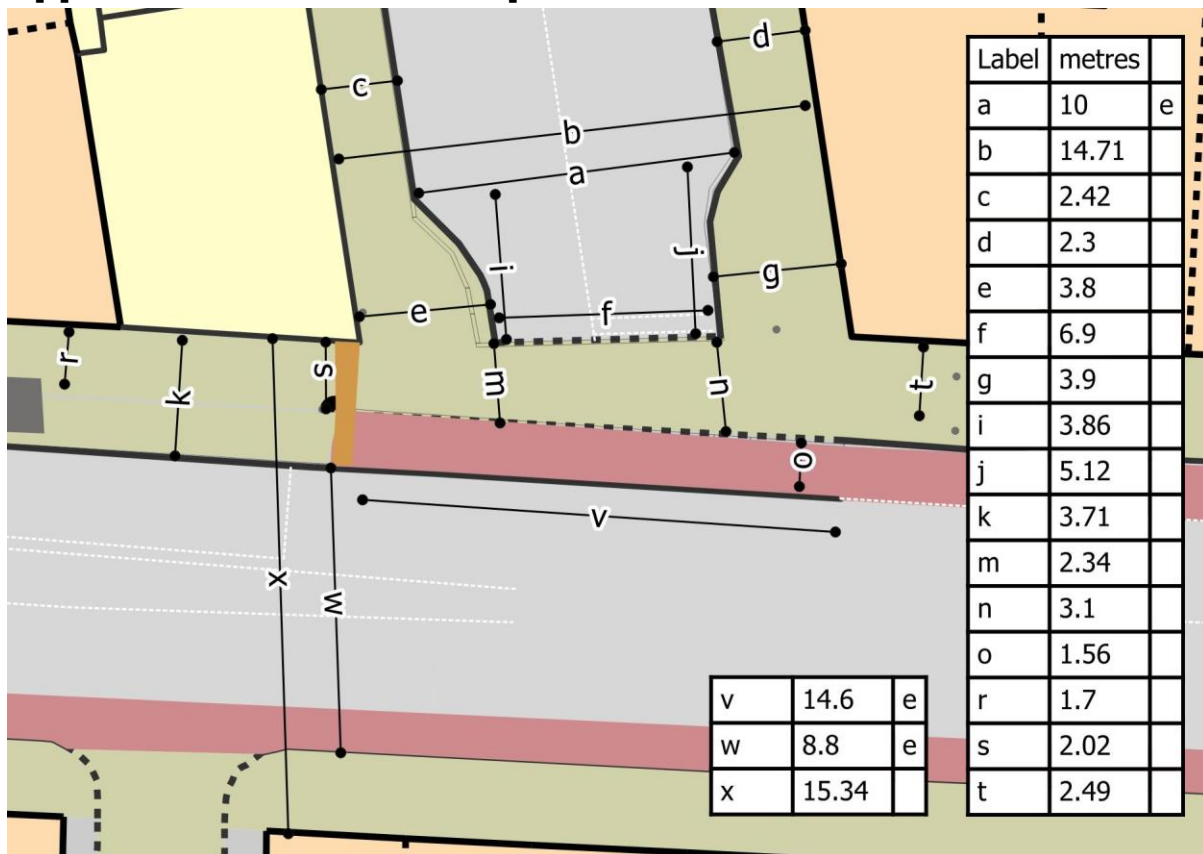
Approximate dimensions/plan

'e' indicates estimated dimension Background mapping © Crown copyright 2023, OS 100046668

The space, marked in red on the plan, for cycling, is a cycle track at the junction mouth, but is a painted cycle lane elsewhere in this image (to the right and bottom of the plan).

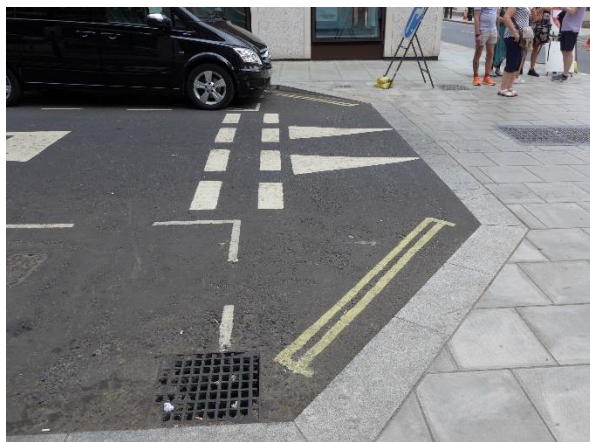
Ramp detail

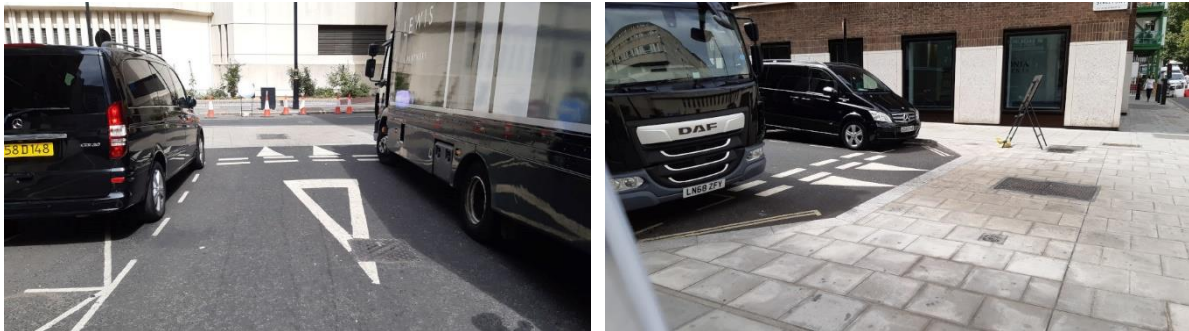
There is an issue here with the visibility of/for pedestrians, caused by parked vehicles at the side road end. Although in the plan view above there is some sense that the drivable space is narrowed by the equivalent of build-out spaces, these are effectively part of the drivable space. There are no obstructions to use of the whole space by vehicles, and vehicles can be parked right up to the edge of this space.

This issue was at its most acute when a delivery lorry was present (see image below), however it remained a problem at other times.

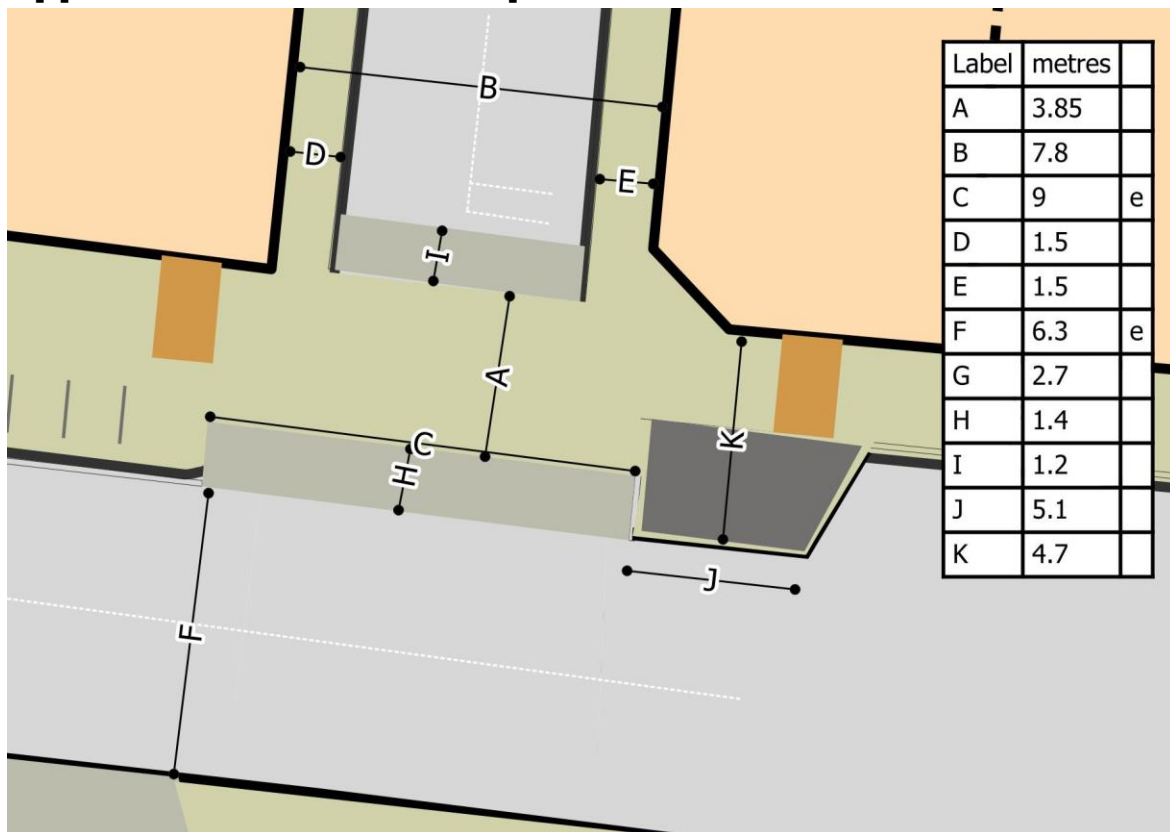
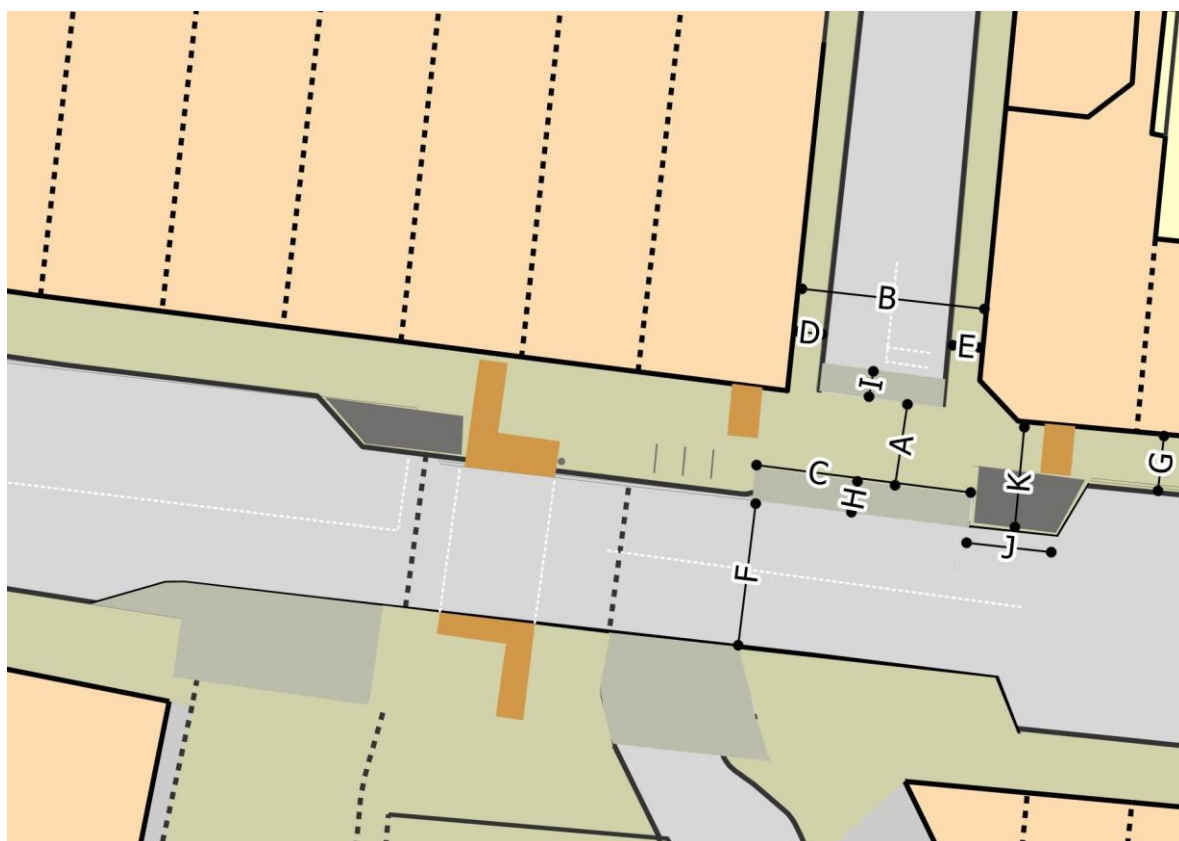
Approximate dimensions/plan

'e' indicates estimated dimension Background mapping © Crown copyright 2023, OS 100046668

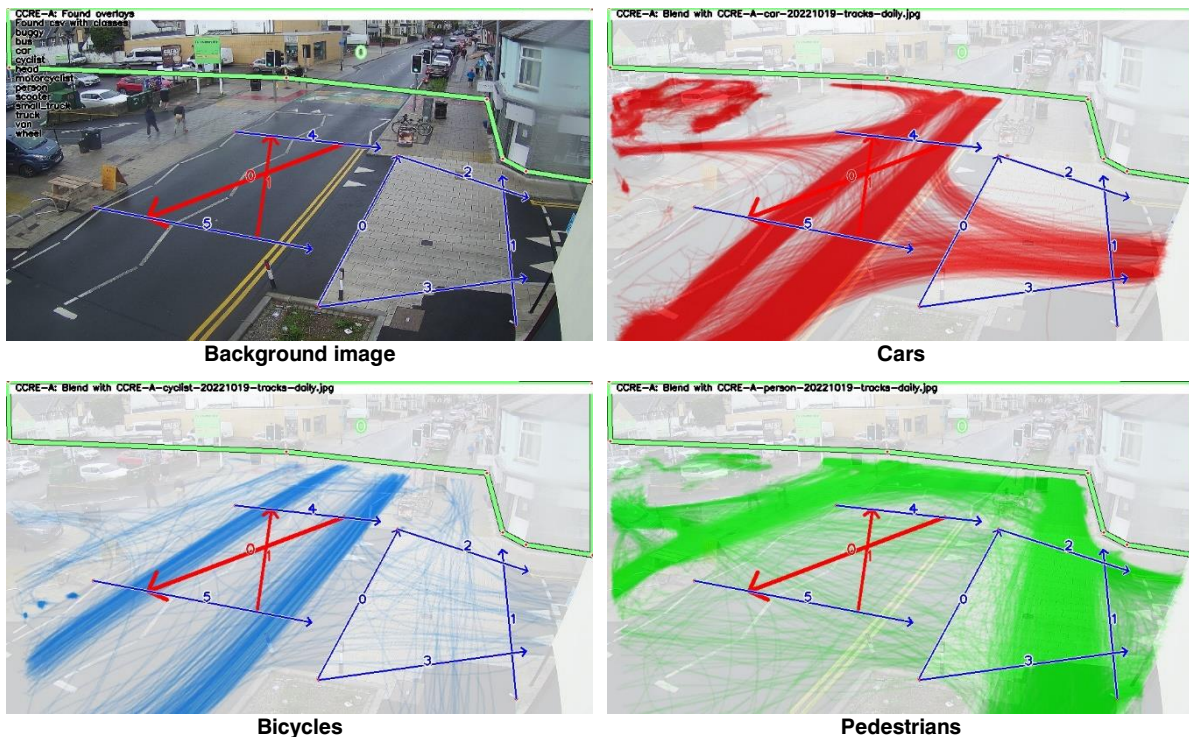
Most cyclists (blue) use the carriageway, but it can be seen that there is some limited cycling on the footway (also on the opposite side of the main road).

There is a high level of pedestrian use (green), and the signalised crossing and Glamorgan Street itself can be seen to be well used.
